West Beach Sloping Timber Breastwork

Potential structural failure – Winter 2009 / 2010

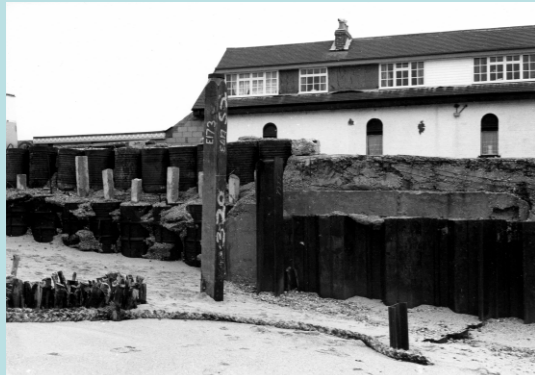
Start of construction, Dec '75

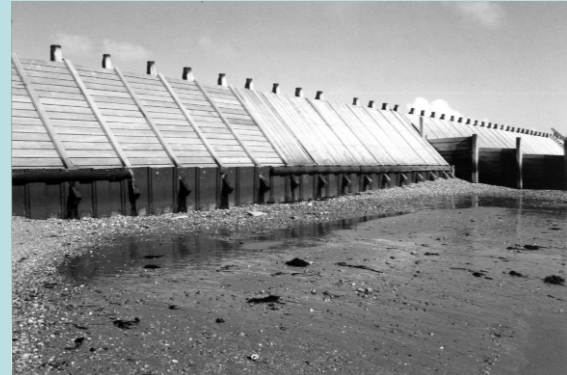
Low beach levels, Oct '90

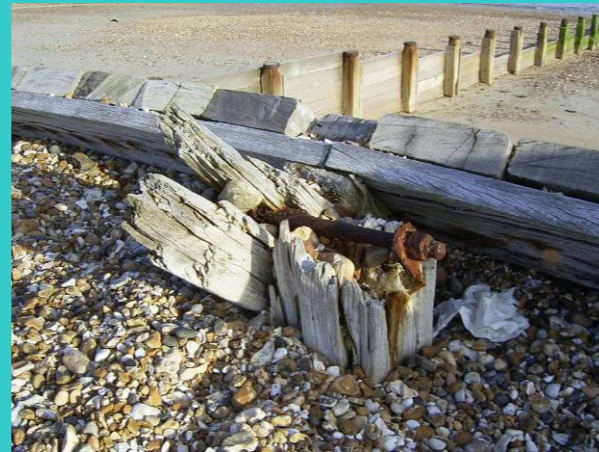
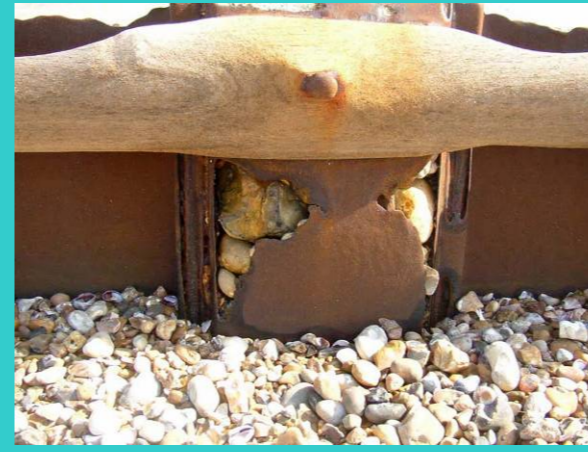
- The structure is reaching the end of its serviceable life and is in a poor condition

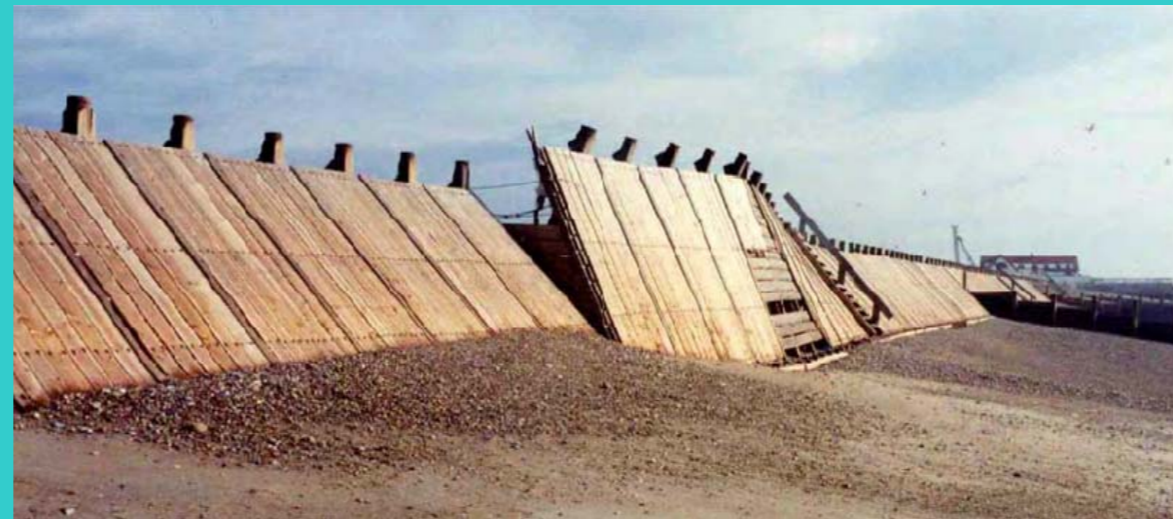
- If beach levels drop during a winter storm there is a risk that the structure could fail in a similar manner to the event shown below (Feb 1990)

Significant structural failure, Feb '90

- The area behind the structure is designated a Site of Special Scientific Interest (SSSI) and is managed in agreement with Natural England
- Havant Borough Council have an emergency response plan in place should a structural failure occur over the coming winter months
- No works are planned to demolish stable sections of the structure, only in response to structural failures

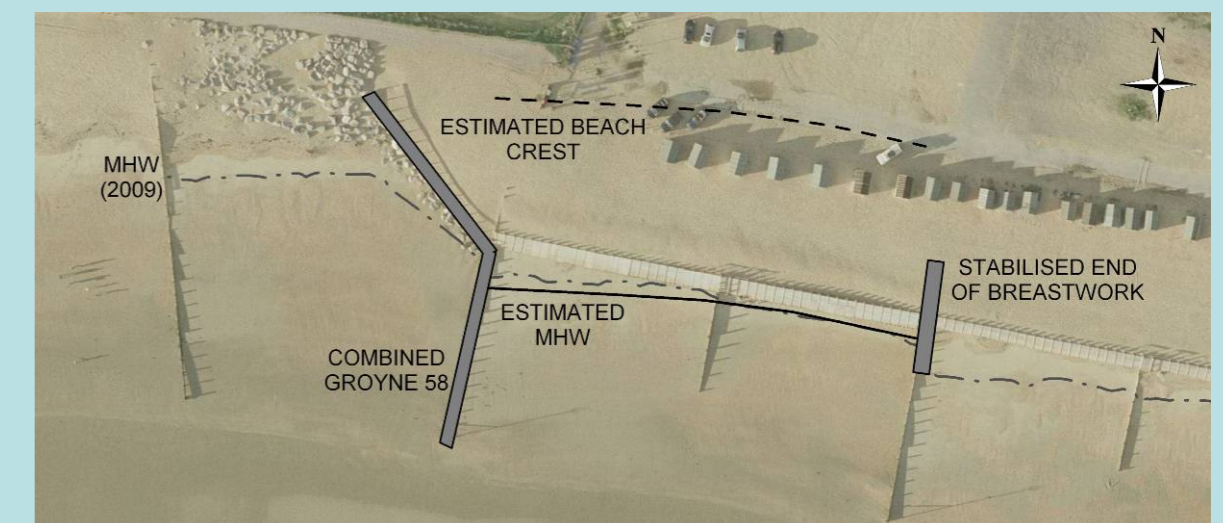
- If the structure fails the beach crest will retreat back to more stable position
- Given the most likely failure point the potential retreat of the beach crest is shown below
- Depending on the exact location of a failure, beach huts and car parking could be impacted
- Beach hut owners will be contacted to discuss the options available to them should a failure occur

Likely form of coastline given most probable failure scenario
